Cavitation in Centrifugal Pumps

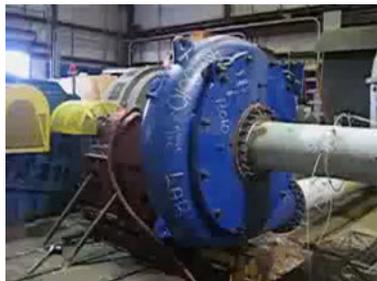
Click photo for short 29 sec video with sound of cavitation in pump

1. The cavities or bubbles will collapse(implode) when they pass into the higher regions of pressure, causing noise(see video below), vibration, and damage to many of the components.
2. We experience a loss in capacity.
3. The pump can no longer build the same head (pressure)
4. The pump's efficiency drops.

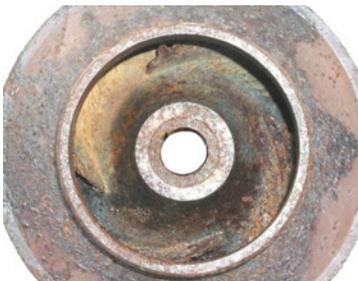
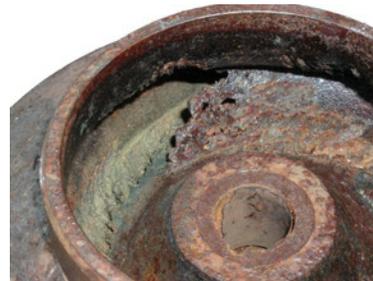
Two photographs above of the same impeller.

Suction cavitation has damaged the leading edge and suction side of the vane, and also damage is observed on "corner" surfaces leading into the vane.

Cavitation damage is mostly observed at the impeller inlet since this is where the lowest pressures occur in the pump.

If the incoming liquid is at a pressure with insufficient margin above its vapor pressure, then vapor cavities or bubbles appear along the impeller vanes just behind the inlet edges and cause the following results:
