Electrical measurements on adjustable speed drives

Ten measurements that tell you a lot

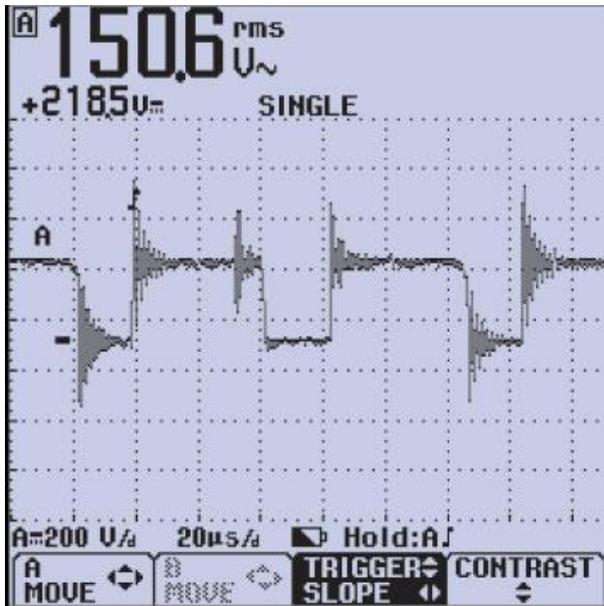
The trend with PWM drives has been to make the rise time of the pulses as fast as possible to reduce switching losses and increase the efficiency of the drive. However, fast rise times coupled with long cable lengths produce an impedance mismatch between the cable and the motor causing reflected waves, or "ringing" as shown in Figure 3A.

Figure 3A. Reflected voltages (ringing).

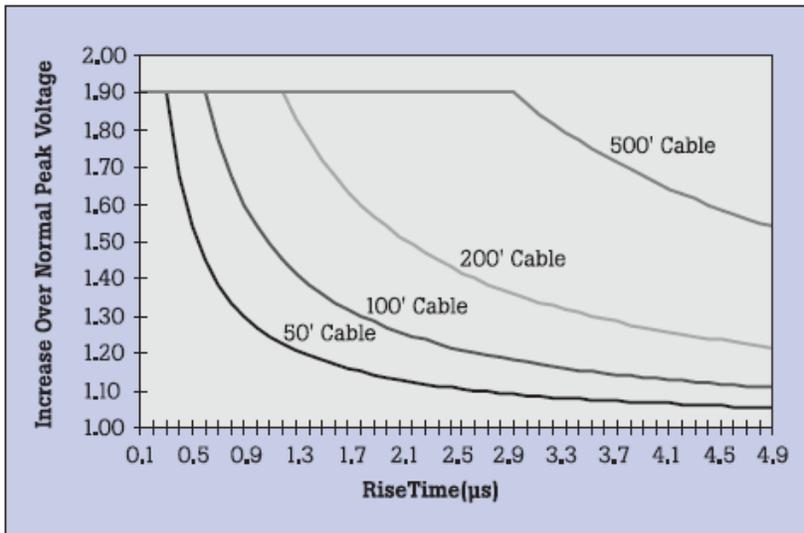
Figure 3B. Impact of rise time and cable length on magnitude of reflected voltages.

The relationship between cable length, rise time and the resultant increase in peak voltage is illustrated in Figure 3B. The peak voltage at the motor terminals will increase above the dc bus voltage of the ASD as cable length increases and the rise time of the ASD output pulse gets faster.

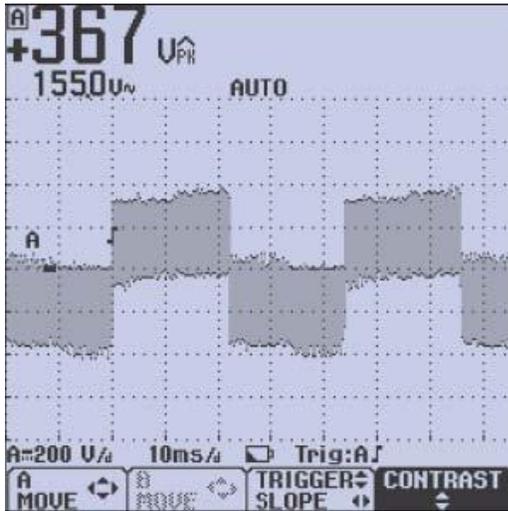
Figure 3C shows the ASD L-L voltage measurement at the motor terminals with six feet of cable, while Figure 3D shows the ASD L-L voltage with 100 feet of cable. Notice the difference in peak voltage

Figure 3C. Normal PWM waveform.

measurements—about 210 volts. Also notice that there is only 5 V rms difference between the two waveforms (small digits on the display). This means your voltmeter will not find this problem.

Very few scopes will trigger as nicely and easily as the Fluke 123 ScopeMeter® Test Tool did for the measurements in Figures 3C and 3D.

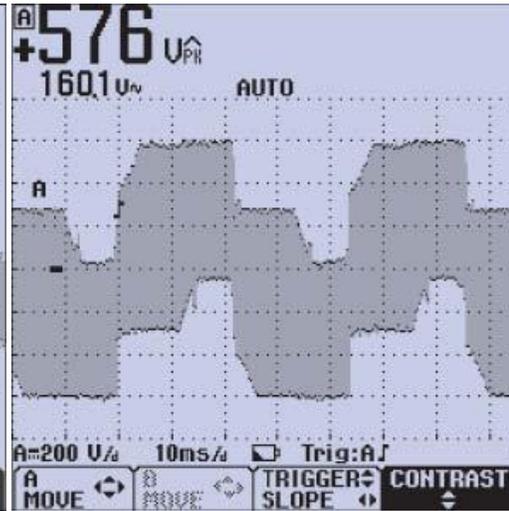
Figure 3D. PWM waveform with reflected voltages.

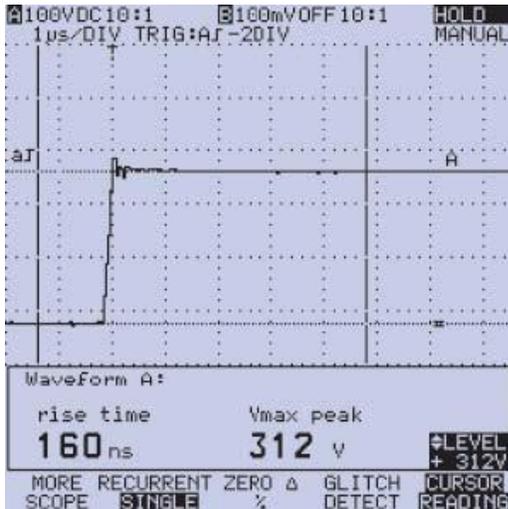
Figure 3E. Leading edge of normal PWM pulse.

The signals in figures 3E and 3F were captured by triggering on a single pulse using single shot mode with cursors enabled to make the peak voltage measurement along with rise time. While this measurement requires more button pressing and scope “know how,” the automated rise time measurement may be worth the trouble. Manually resetting the single shot trigger periodically will give you a sampling of various peak voltages for the different pulses. Also, slowly raising the trigger voltage will give you an idea of the maximum peak when the scope stops triggering.

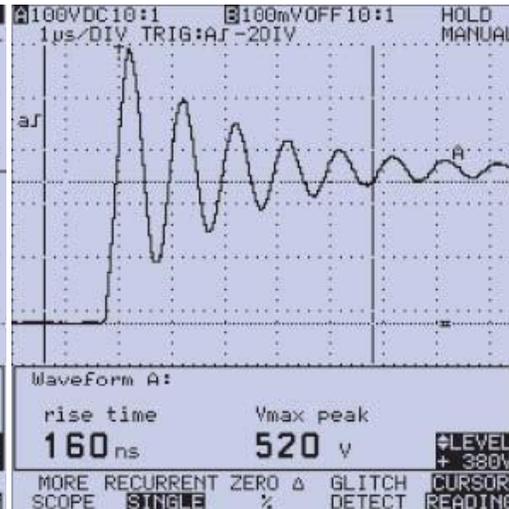
Figure 3F. Leading edge of PWM pulse with reflected voltage (ringing).

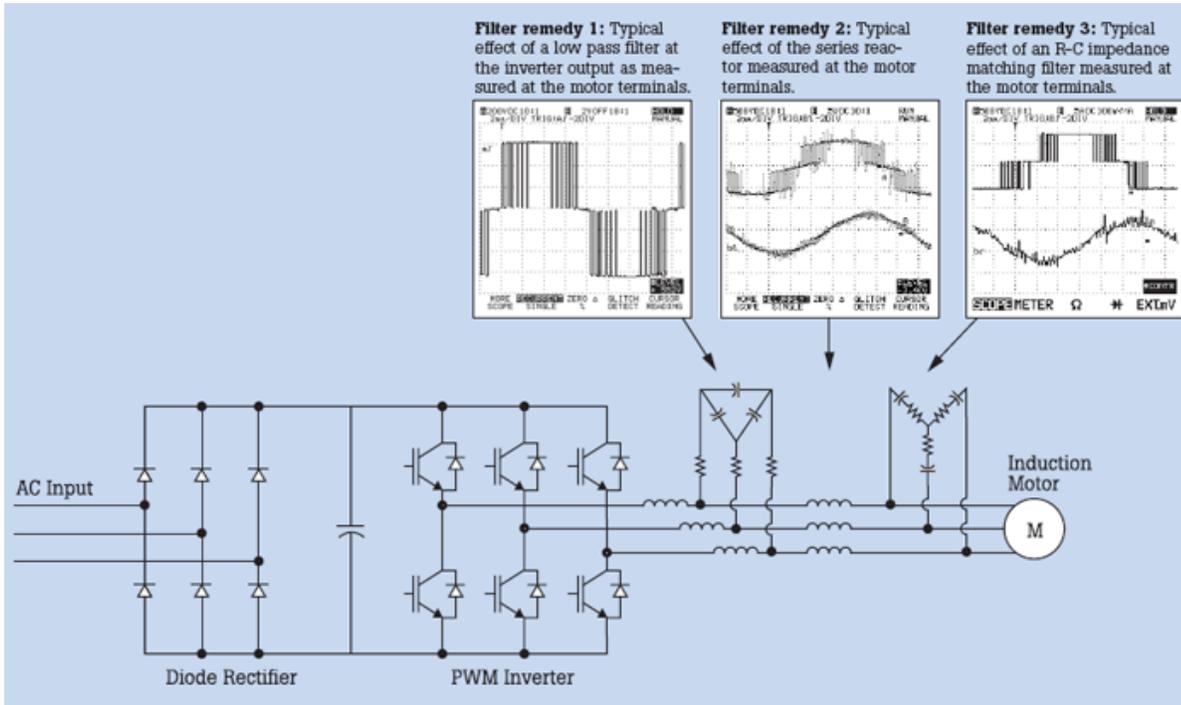
Inverter Output Filter Remedy 1	Series Reactor Motor Remedy 2	Terminal Filter Remedy 3
Series connected to the PWM output terminals.	Series connected to the PWM output terminals.	Parallel connected at the motor terminals.
Designed to slow rise time (dv/dt) below a critical value.	Acts as a current limiter and also slows rise time.	Designed to match the characteristic cable impedance.
Dependent on cable length.	Dependent on size of system.	Not cable length dependent.
Losses dependent on motor kVA.	Losses dependent on motor kVA.	Losses are more or less fixed.
Size/cost dependent on motor kVA.	Size/cost dependent on motor kVA.	Size/cost more or less fixed.

1. An external "add-on" low pass filter can be installed between the PWM output terminals and the cable to the motor to slow the rise time.
2. Install an R-C impedance matching filter at the motor terminals to minimize the overvoltages, or ringing effect.
3. In some applications, such as submersible pumps or drilling machines, it isn't possible to access the motor terminals and other methods of minimizing overvoltages are required. One method is to apply series reactors between the PWM output terminals and the cable to the motor. While this is a fairly simple solution, the reactors may be fairly large, bulky and expensive for large horsepower applications.

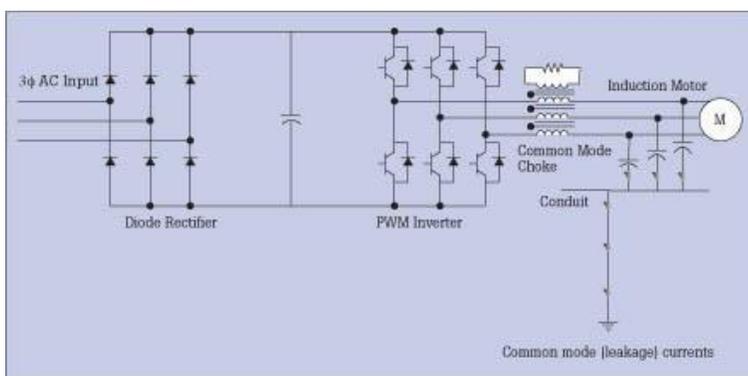
A common mode choke can be used to reduce leakage currents (see Figure 5A). Also, special EMI suppression cables can be used between the drive output and the motor terminals. The copper conductors of the cable are covered with ferrite granules, which absorb the RF energy and convert it to heat. Isolation transformers on the ac inputs will also reduce common mode noise.

Figure 5A. Common mode choke with dampening resistor to reduce leakage currents.

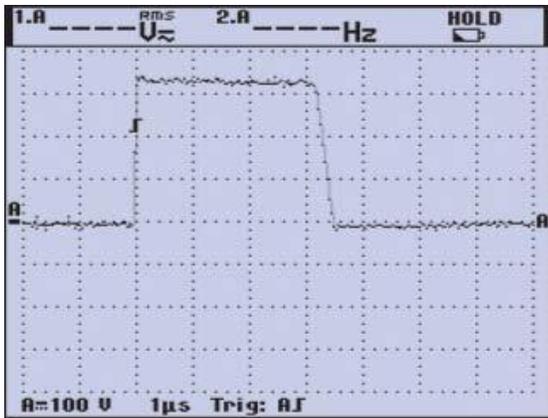
Figure 6A. Square waves.

1. 1. Check positive conducting IGBTs by connecting the scope common lead to the dc+ bus and measuring each of the three phases at the inverter's motor output terminals. Check for nice, clean-edged square waves without any visible noise inside the pulses, and that all three phases have the same appearance.
2. 2. Check negative conducting IGBTs by connecting the common lead to the dc- bus and performing the same measurements as in step one above on each of the three phases at the inverter's motor output terminals.

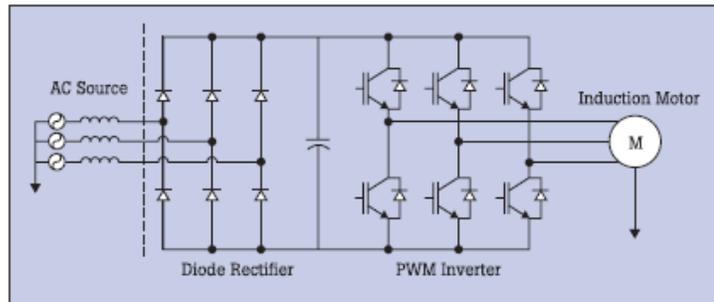
Figure 6B. Check all three phases at the inverter's motor input terminals.
